# Manhole Inspection Summary

Manhole # S29MM1077MH

Record Plat: **29MM1** Node: **077** Status: **New Manhole (Not in GIS)** Insp Date: **5/14/07 12:00 AM**

**Location** Address: **4507 WILMSLOW RD** Cross Street: **COLD SPRING LN**

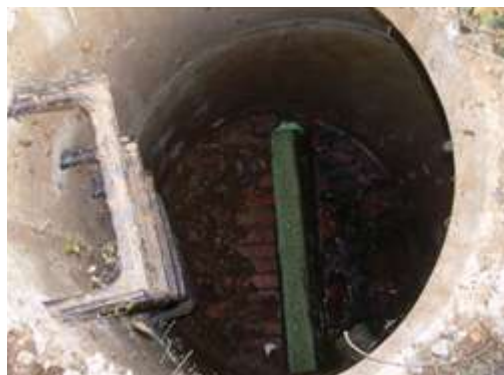
Top View

Bench debris.

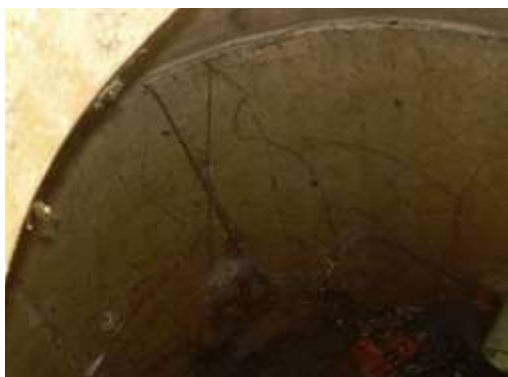
Defect

**Corbel** Material: **Precast Concrete** ☐ Parged Type: **Concentric/Eccentric**  
Condition: ☐ Sound ☐ Cracked ☒ **Root Intrusion** ☐ Loose Brick ☐ Deteriorated  
Infiltration: ☐ None ☒ **Joint** ☐ Cracks ☐ Mortar ☒ **Roots** ☐ Wall

Corbel root intrusion and infiltration.

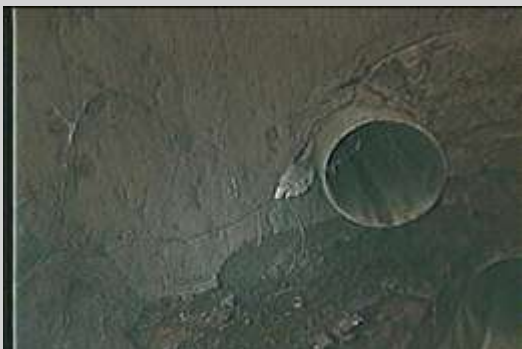
### 6 in. Circular Gravity Sewer Pipe In @ 5 O'Clock

**Barrel** Material: **Precast Concrete** ☐ Parged  
Shape: **Circular** Diameter: **48** (in.) Length: (in.)  
Condition: ☐ Sound ☐ Cracked ☒ **Root Intrusion** ☐ Loose Brick ☒ **Deteriorated**  
Infiltration: ☐ None ☐ Joint ☐ Cracks ☐ Mortar ☒ **Roots** ☐ Wall

Barrel deterioration, root intrusion and infiltration.

Infiltration: **Evidence** Pipe Seal Cond: **Cracked**

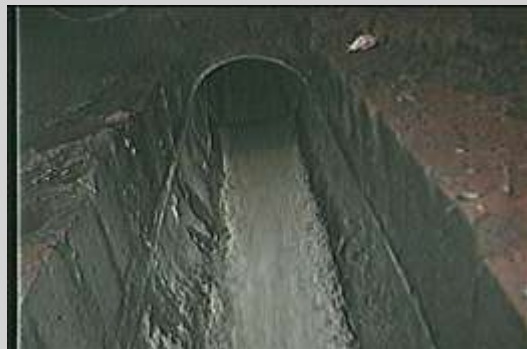
Pipe In @ 6 O'Clock

Pipe Seal Cond: **Cracked**
